Navajo Abandoned Uranium Mine Site Screen Report

Diamond No. 2 AUM Site

Navajo AUM Eastern Region

May 2009

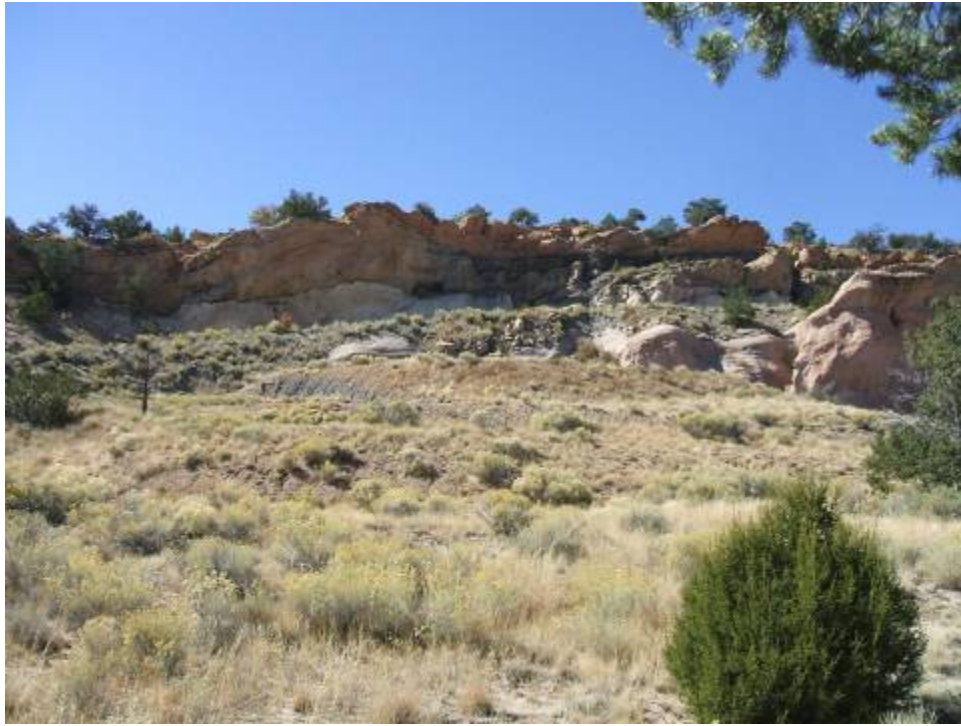
Photo 1. Diamond No 2 mine site, slope and cliff area, towards the west

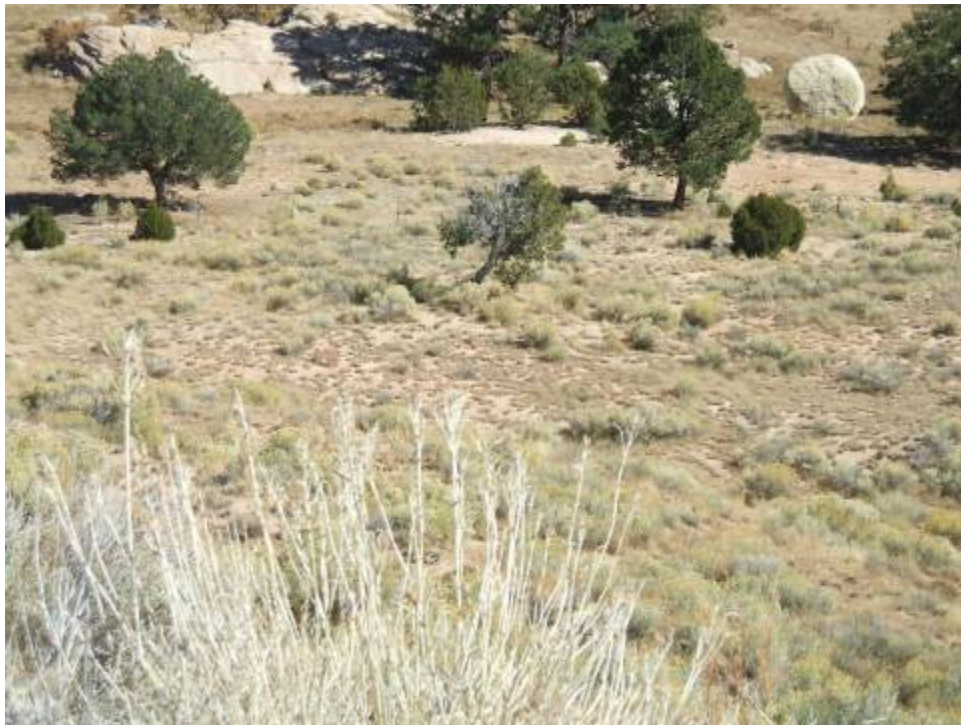
Photo 2. Diamond No 2 mine site, flat area, towards the east

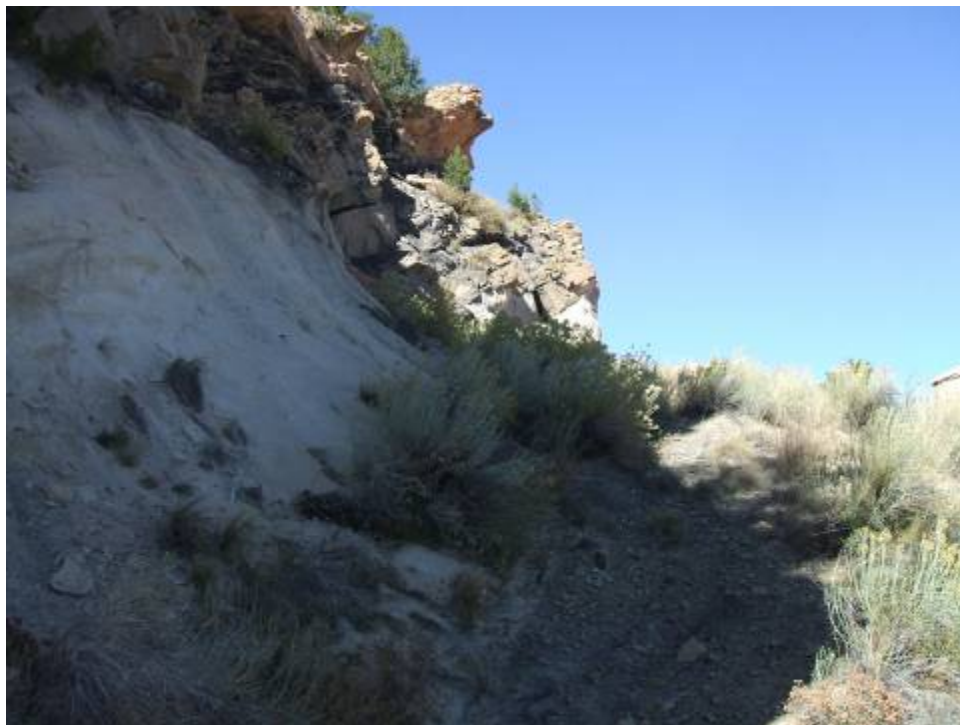
Photo 3. Diamond No 2 mine site, cliff wall area, towards the north

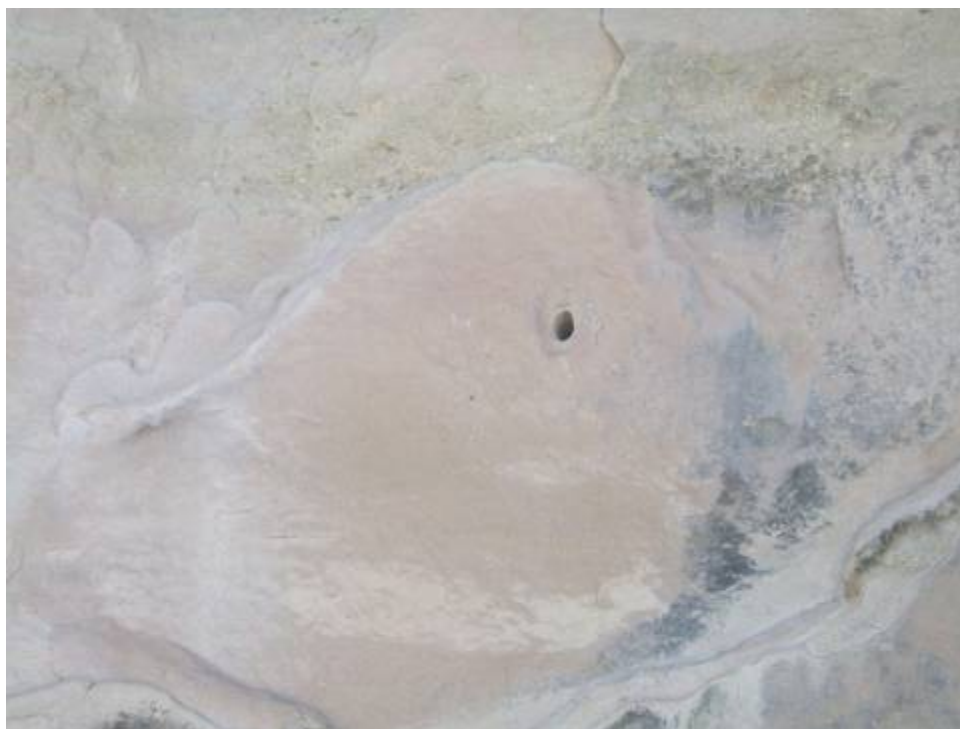
Reclamation status of the mine site is currently unknown. No visible signs of reclamation were observed. Three adits/shafts were observed along the cliff face at the western end of the site (Photo 5). Several drill-holes were also observed along the cliff face (Photo 4). No waste piles, or other mine features were observed during the site visit.

Photo 4. Diamond No 2 mine site, possible blasting hole on the cliff wall, towards the west

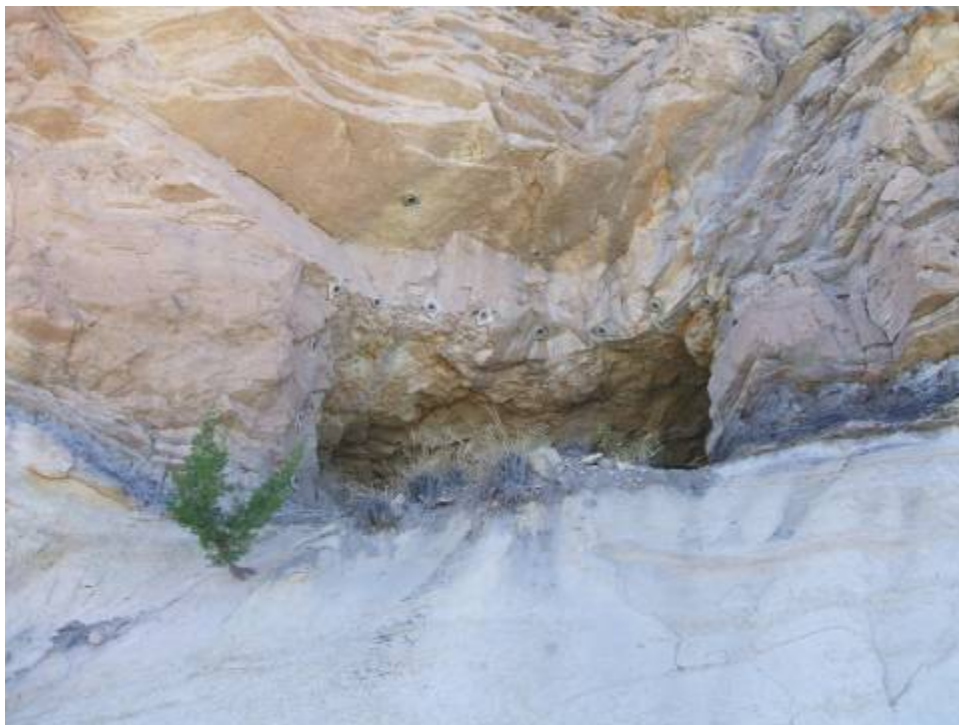
Photo 5. Diamond No 2 mine site, adit / shaft entrance in cliff wall, towards the west

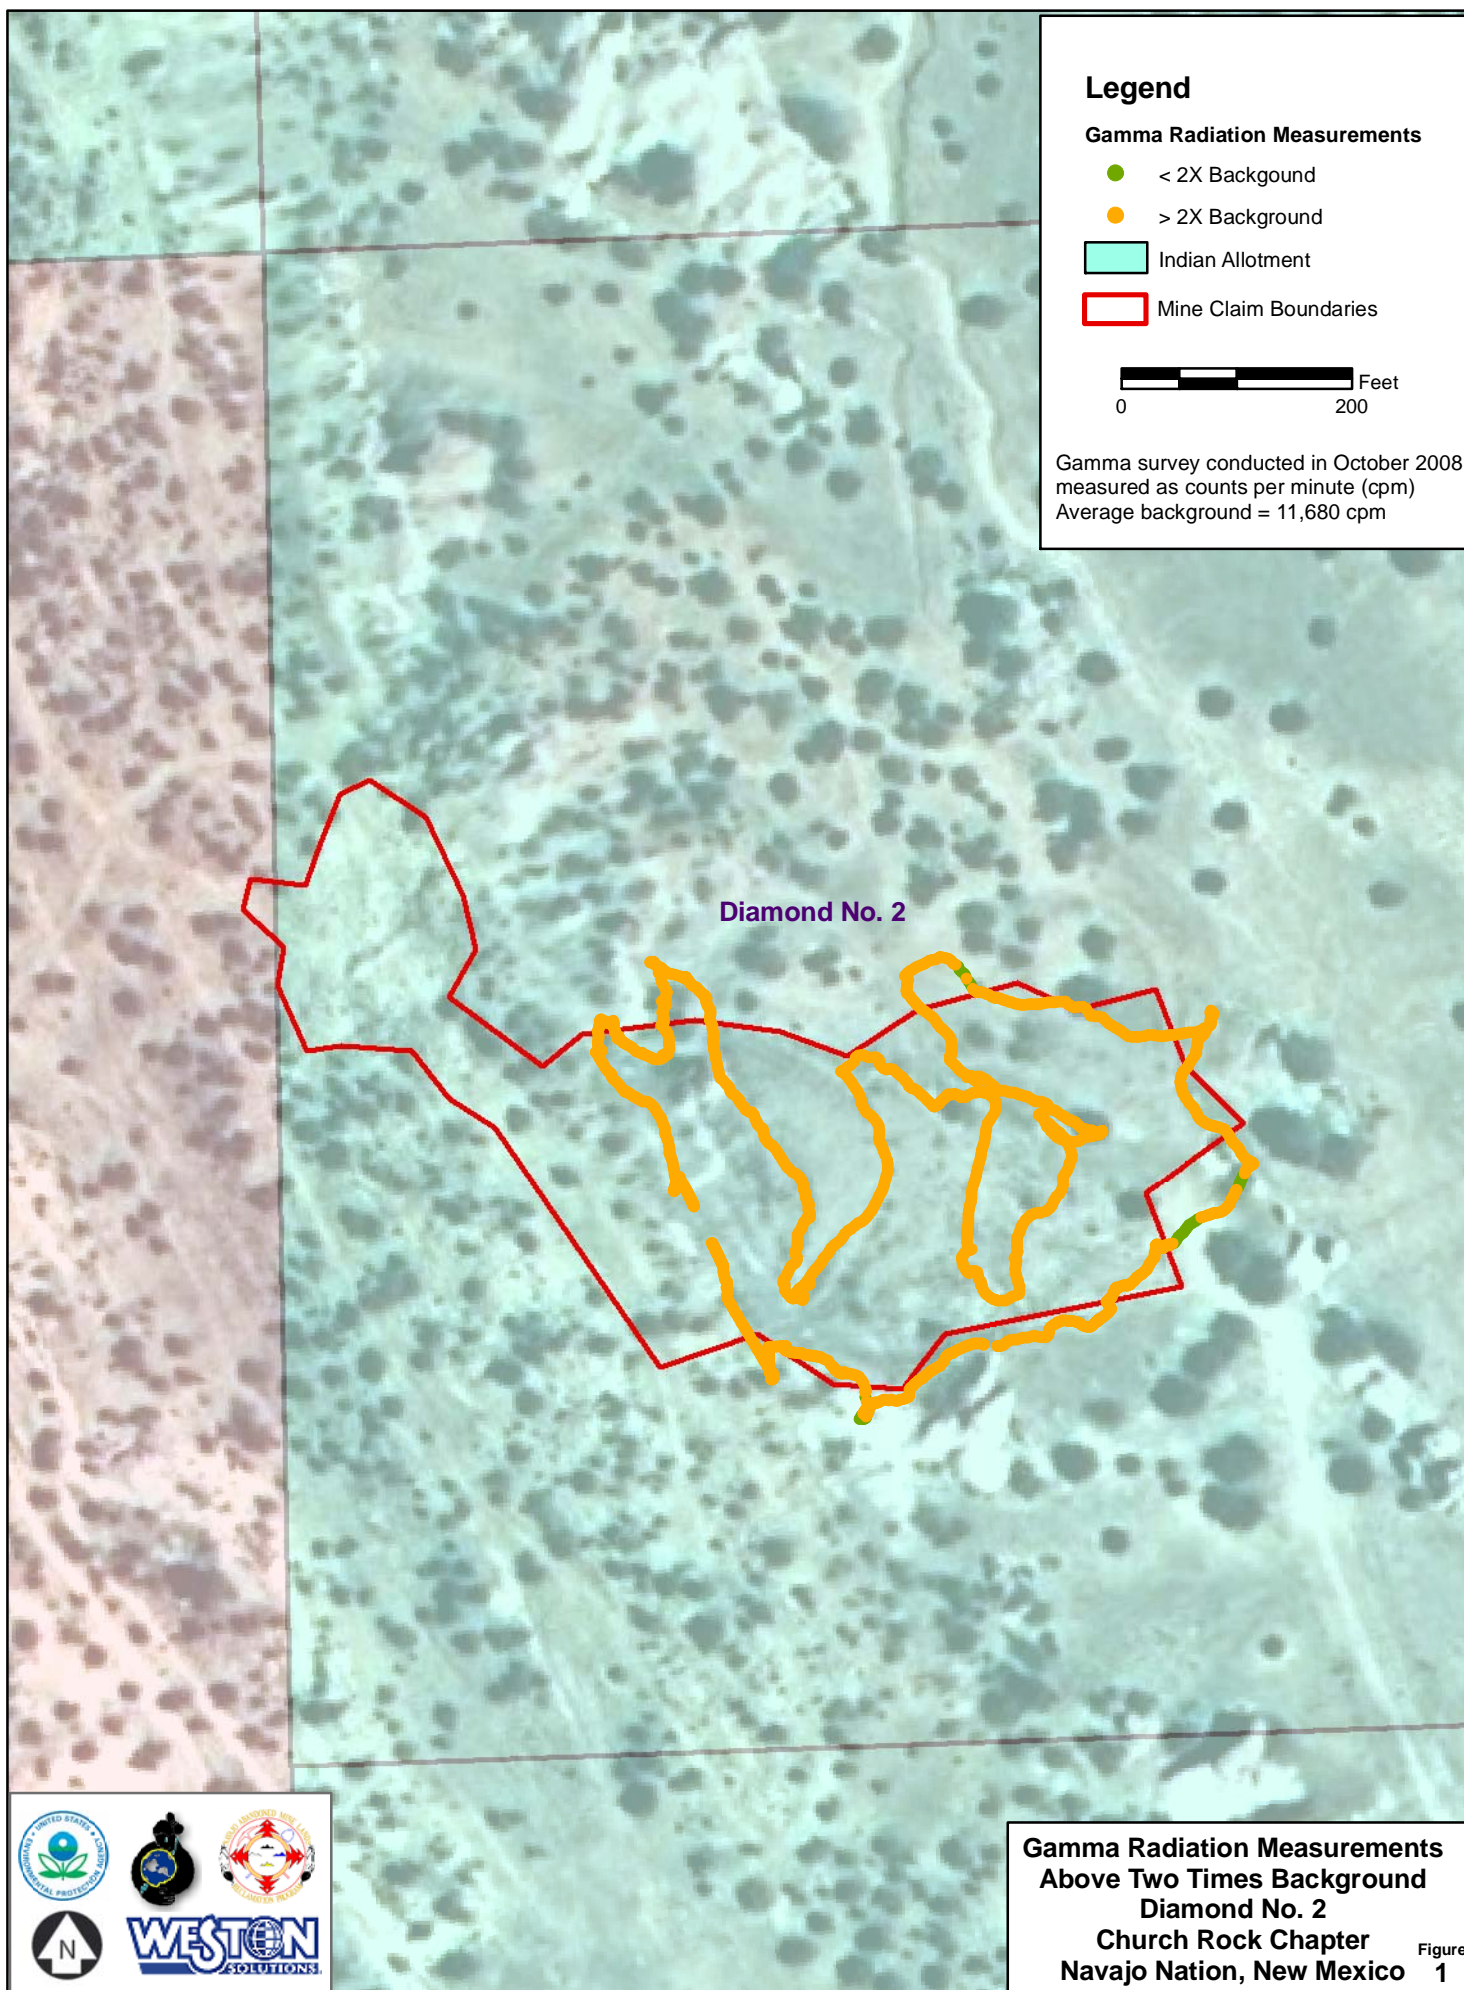
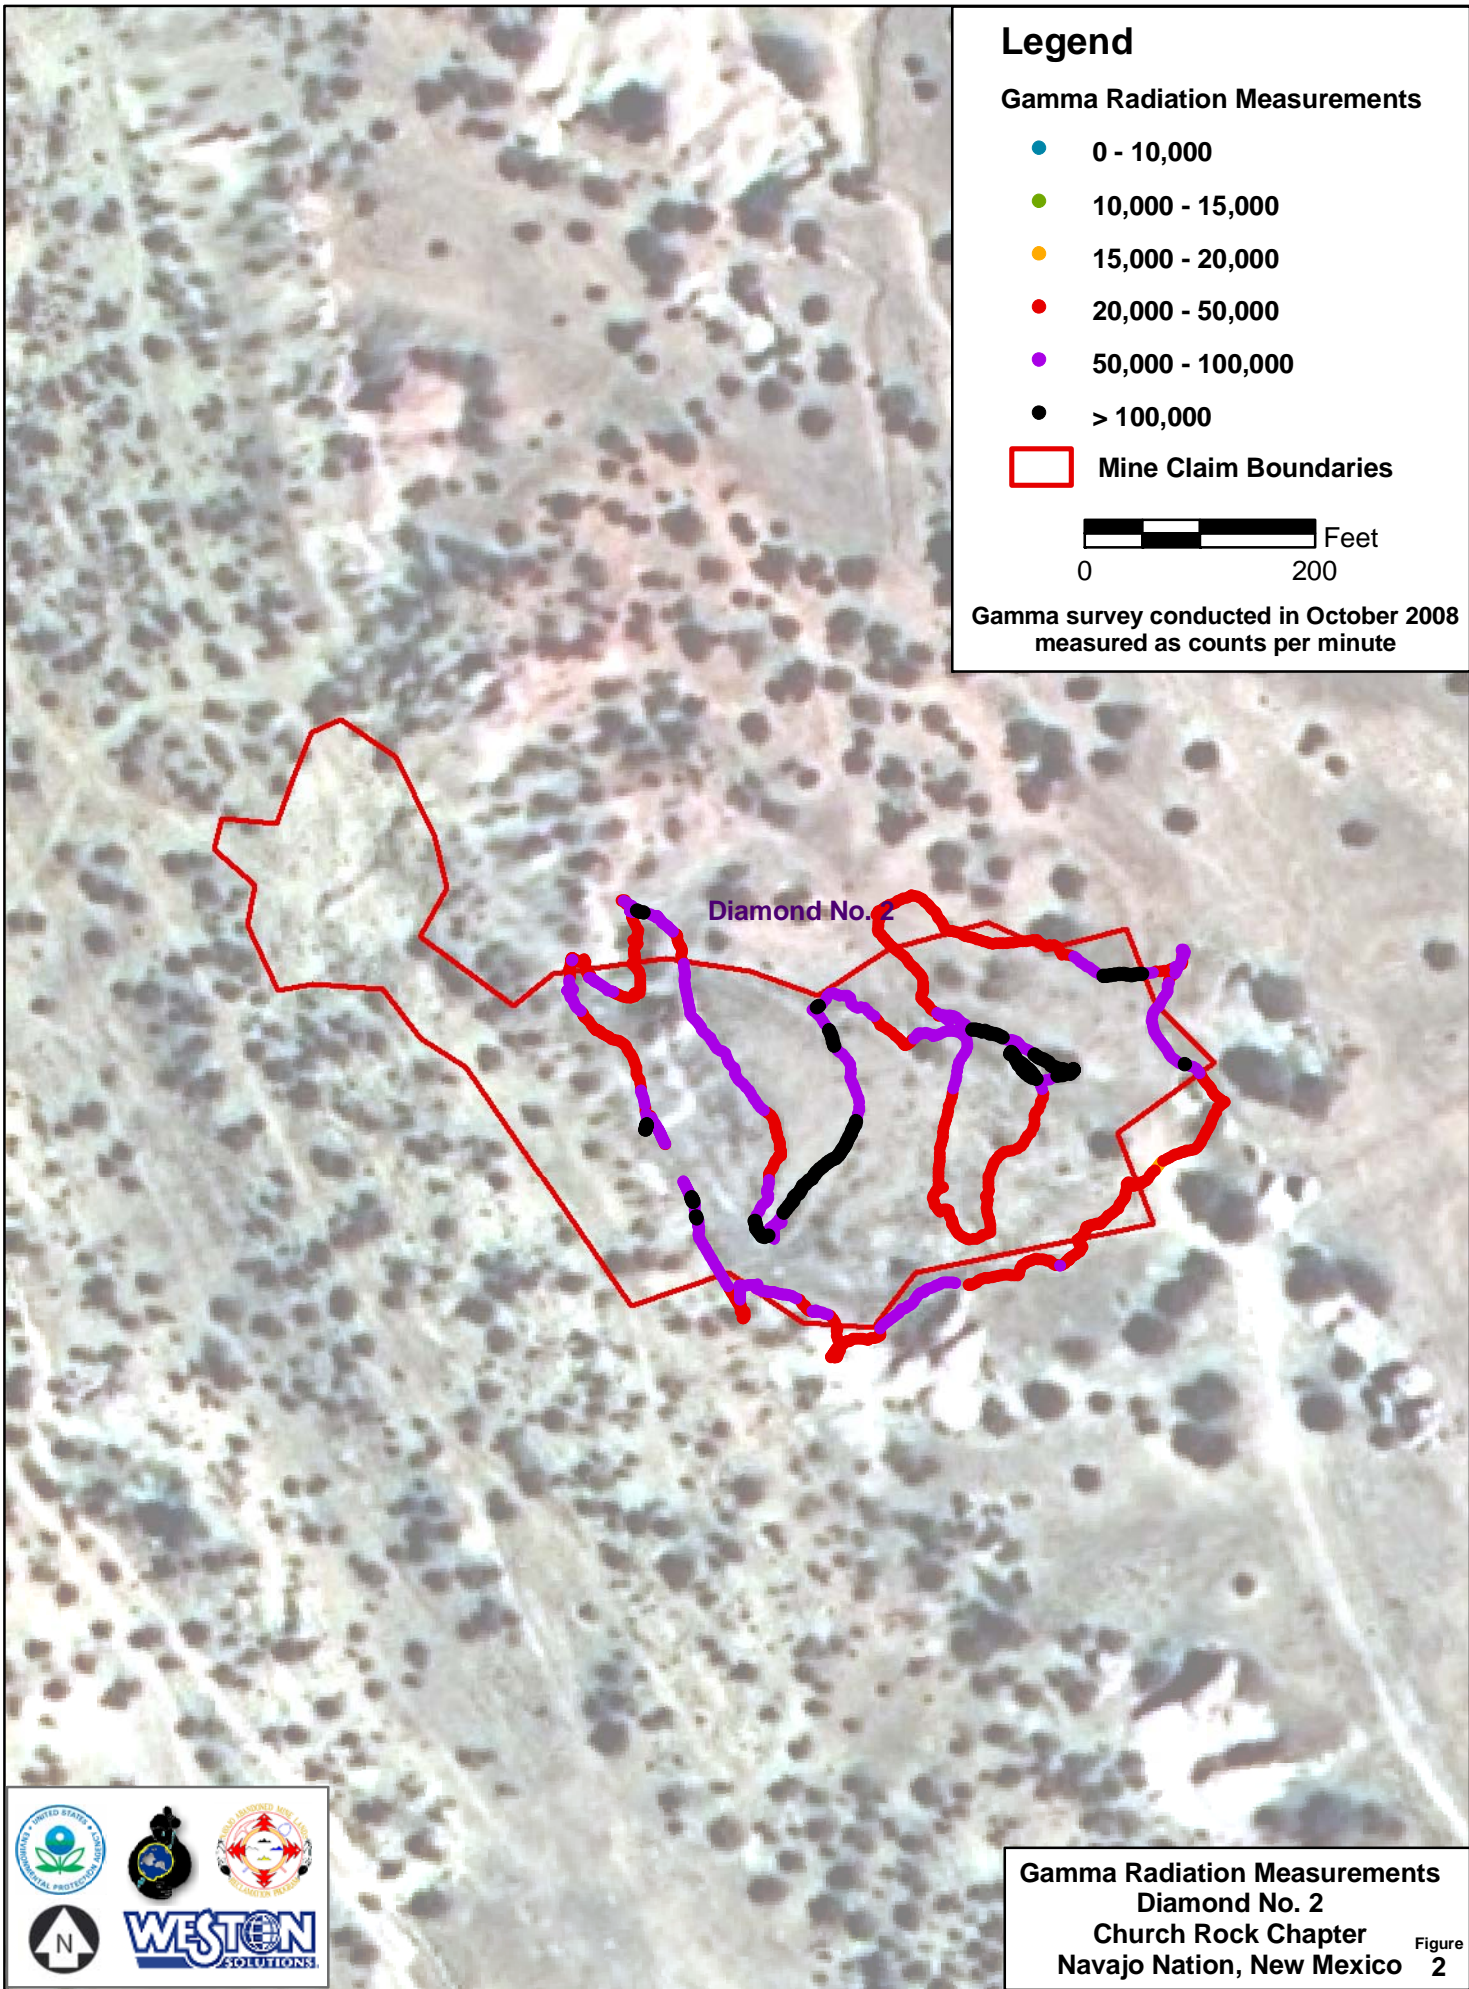
A total of 1,704 gamma radiation measurements were collected from mine sites, ranging from 18,515 cpm to 166,251 cpm. The measurements are represented in Figures 1 and 2.
